King County Wagners Bridge

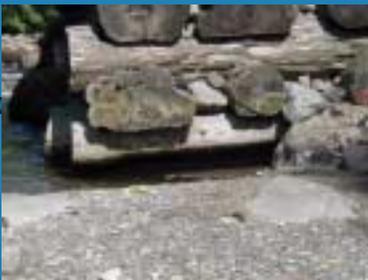
King County Wagners Bridge

Scour at Interior Pier

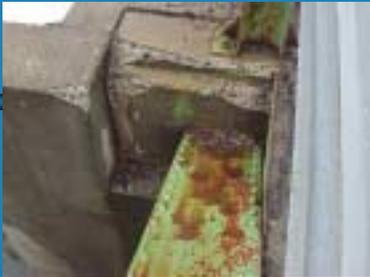
Kittitas County W Fork Teanaway Road

View Steel Members Encased in Concrete

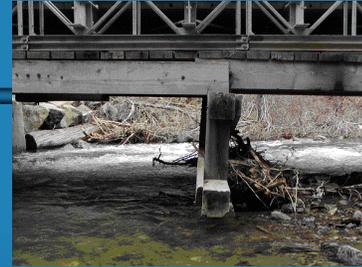
Chelan County Old Blewett 1

Original Timber Bridge Pier

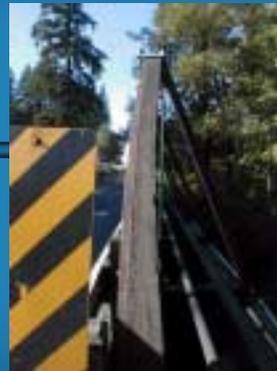
Clark County Betts Bridge

View of Bowed Timber Member

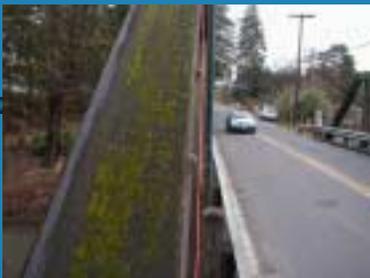
Clark County Betts Bridge

Deviation from String Line

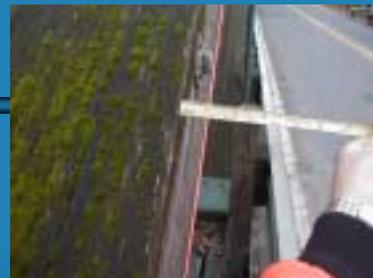
Clark County Betts Bridge

Measurement of Bow in Timber

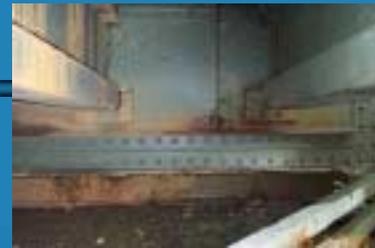
Whatcom County Middle Fork Bridge

Typical Superstructure Condition

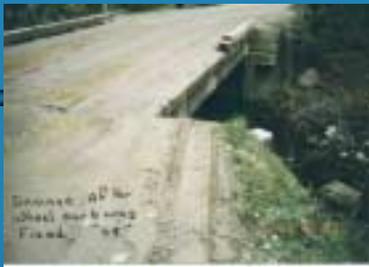
Pend Oreille County North Fork Calispel

Close-up of Deck

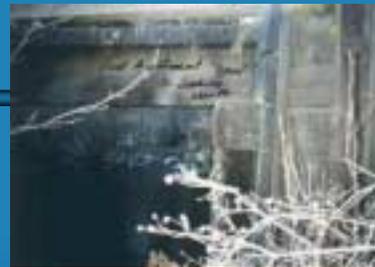
Pend Oreille County North Fork Calispel

Timber Abutment

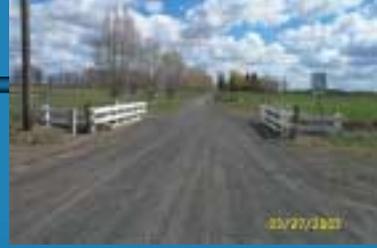
Grant County 4-SE

Deck View with Posting

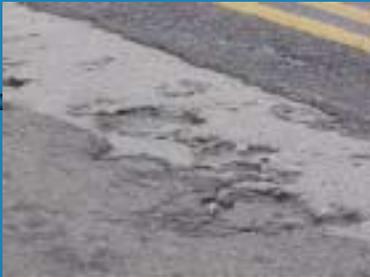
Typical Deck Condition

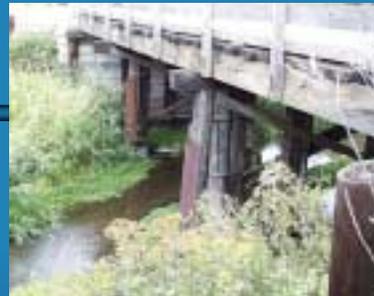
Substructure View

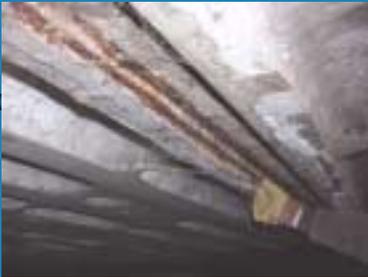
View of Exposed Rebar

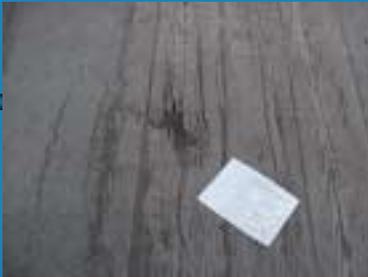
Timber Deck Condition

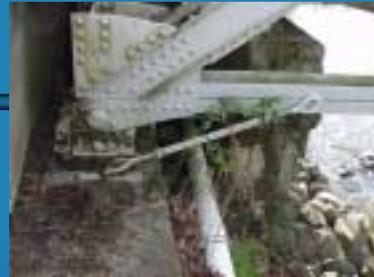
Typical Bearing

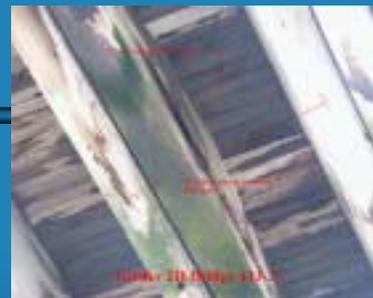
Stringer Replacement

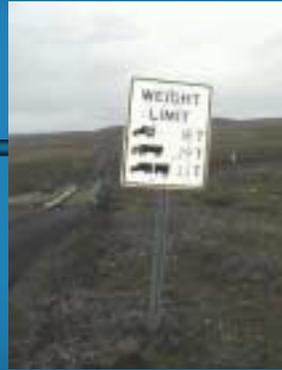
Deck View with Posting

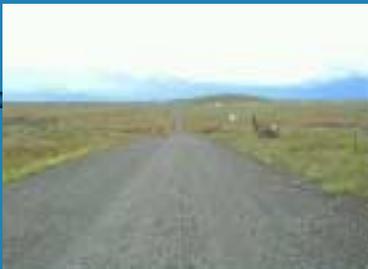
Sight Distance

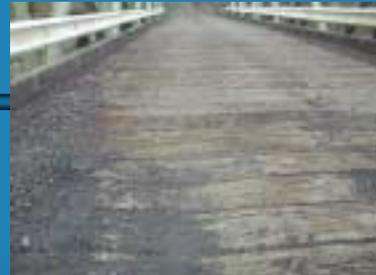
Deck View with Section Loss in Timbers

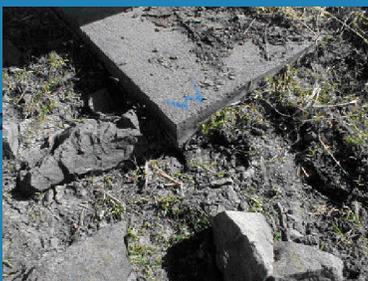
West Pier Footing is Exposed

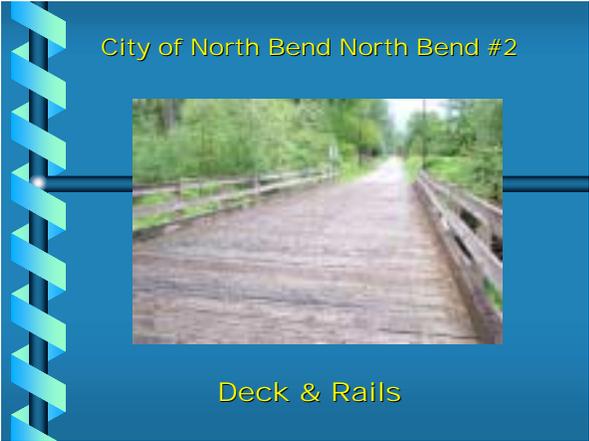
Deck & Rails

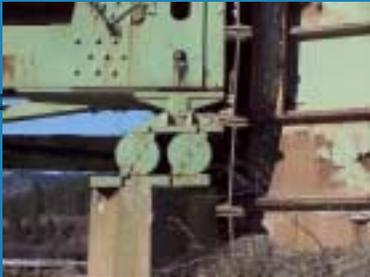
Bridge Expansion into Backwall

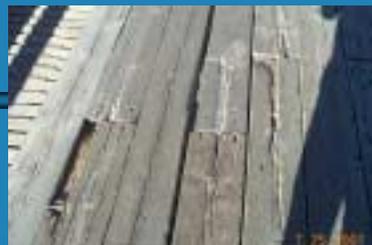
Typical Deck Condition

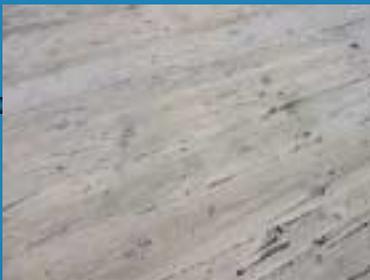
Deck Condition

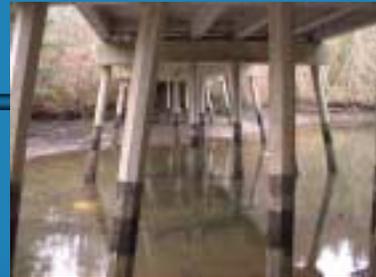
Substructure View

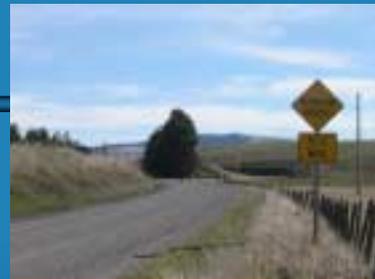
Narrow Bridge Posting

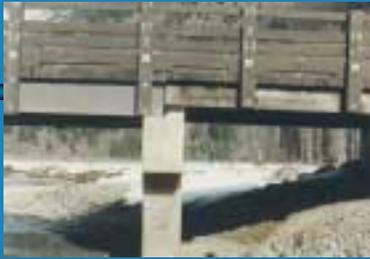
Substructure Detail

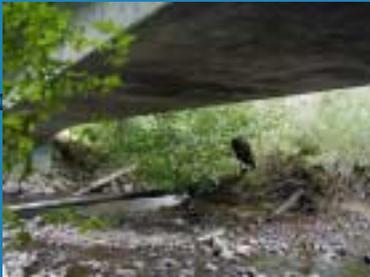
View of Substructure

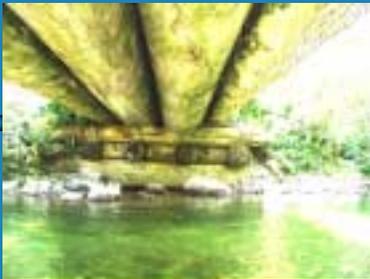
Log Stringer and Log Crib Abutment

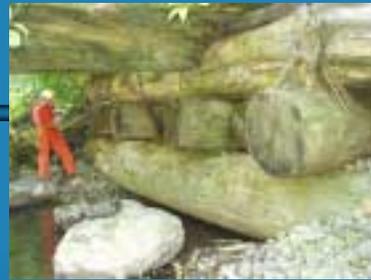
Scour Hole Under Abutment

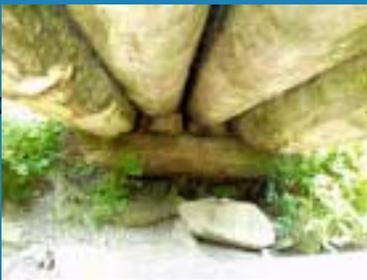
Log Mud Sill

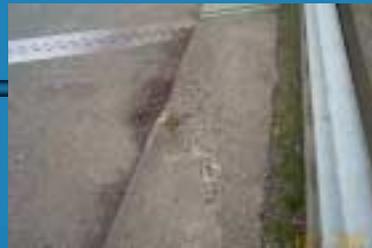
Typical View of North Sidewalk
